Multi-Municipal Wind Turbine Working Group

RE: Wind Turbine Failures

Wind Turbine Failures

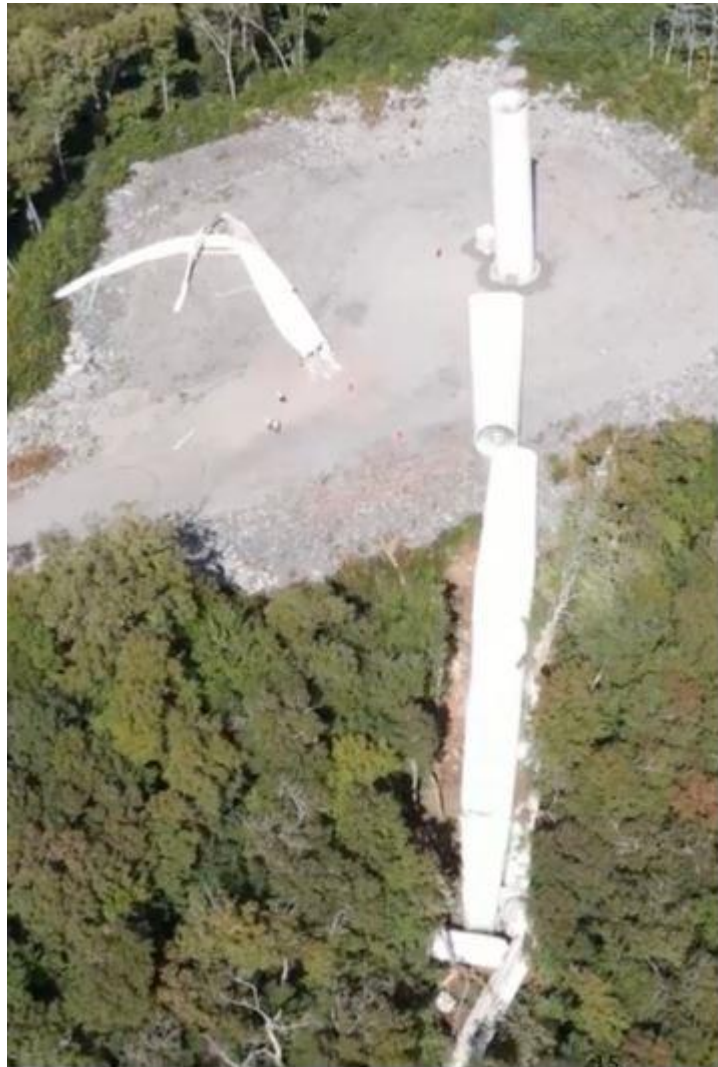
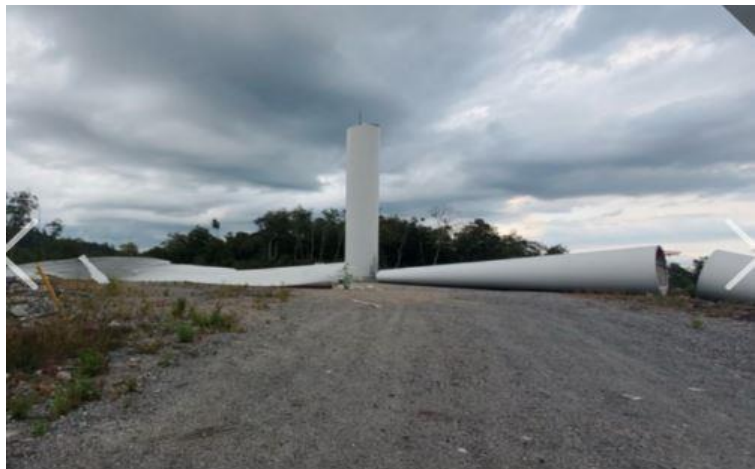
Attachment 1: Bow Lake, Algoma Region, Ontario

The pictures strongly suggest that the failure mechanism was fatigue of the bolts holding the tower together. There is no evidence of buckling, tearing of the steel plate or general deformation at the adjoining section flanges.

A portion of one blade was found located on the ground near the tower base. The other two blades appear to have remained attached to the rotor as it collapsed into the adjacent trees.

Fatigue damage cannot be seen until a crack develops. Since all aspects of the other towers seem to be identical, it would seem necessary to replace all their tower section bolts.

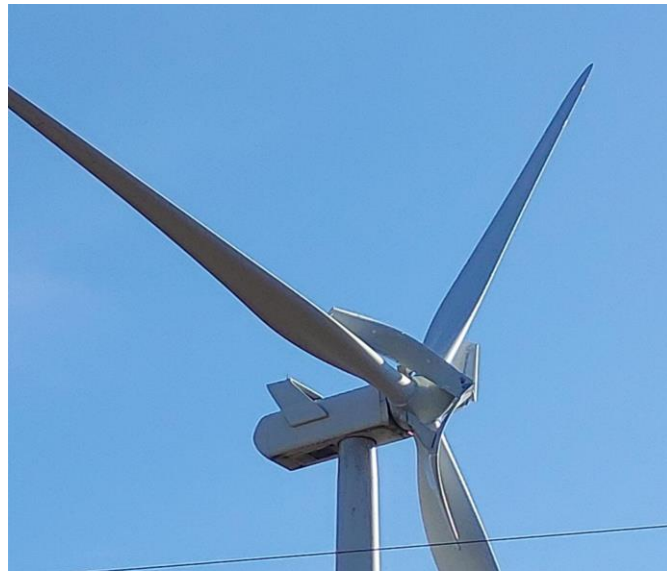
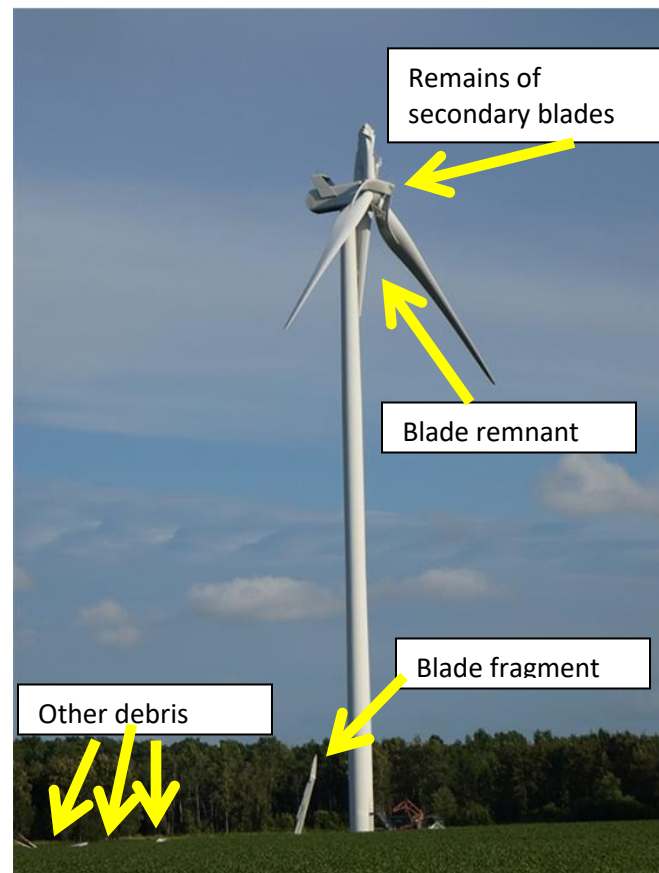
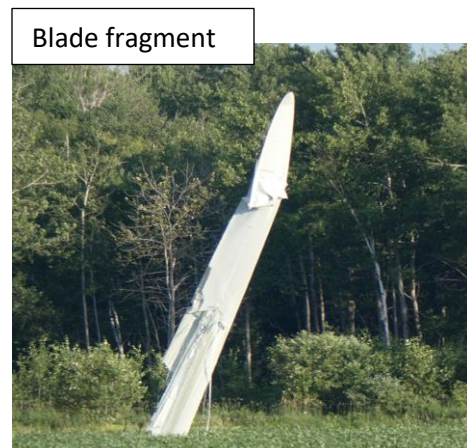
Attachment 2: Skyway 8, Grey County, Ontario

This turbine was retrofitted approximately 3 months prior to the failure with a secondary rotor of three curved blades that fastened to the hub between the existing blades. This experimental device was not part of the original design and was added to increase power output. The failure resulted in the separation of one of the secondary blades and one of the existing blades. Although the exact sequence of the failure is not known, the most likely scenario is that the experimental blade partly separated, impacting the main blade which then failed.

MECP approved the change but there is no public information confirming that the turbine could handle the additional static and dynamic loads imposed by the secondary rotor.

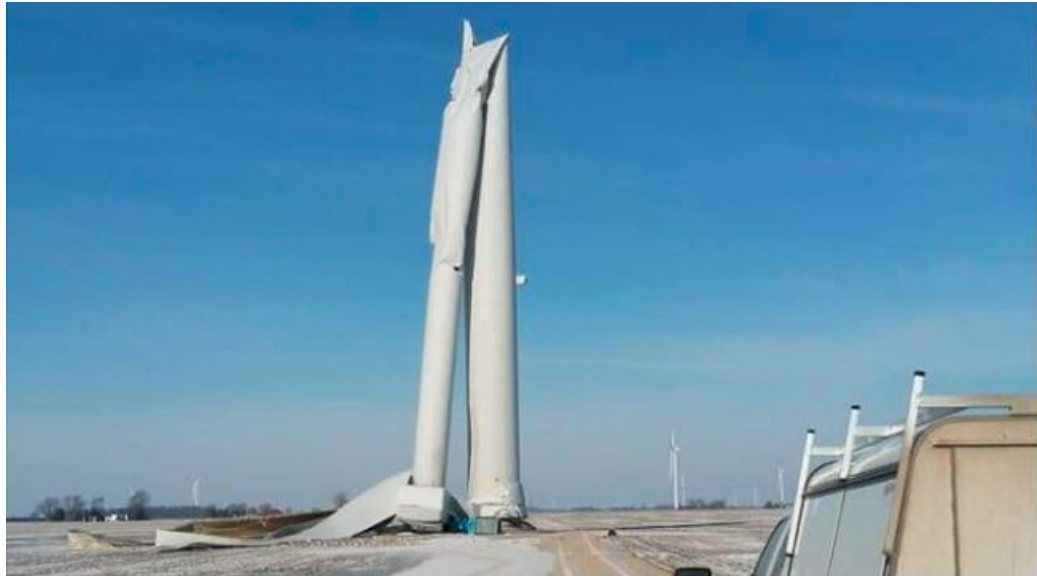
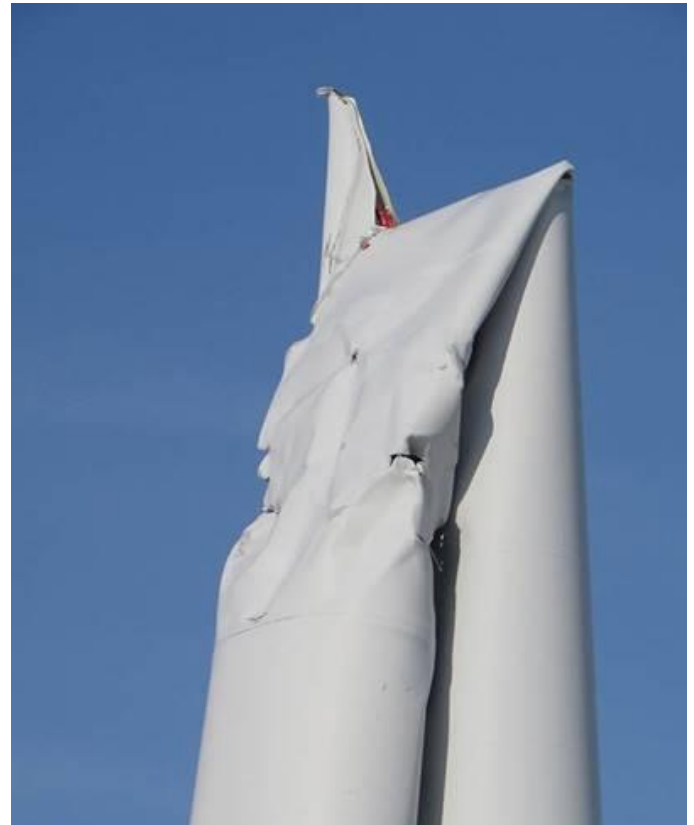
Attachment 3: Raleigh Wind, Chatham-Kent

This tower at Chatham-Kent buckled at approximately its midpoint and fell toward the wind. It was found with one blade wrapped around the tower base and markings on the tower that were above the fold line.

Based on the evidence of publicly available pictures, it seems that the most likely scenario for this catastrophic failure was that the tower was struck by a blade which weakened it such that it collapsed.

If the failure was indeed caused by a blade strike on the tower, this raises questions as to how this occurred. This suggests that the clearance may not have been adequate for the conditions encountered during operation. Alternately the blade may have started to separate and this caused it to get so close to the tower that it made contact with it. There may be other possibilities and variations as well.

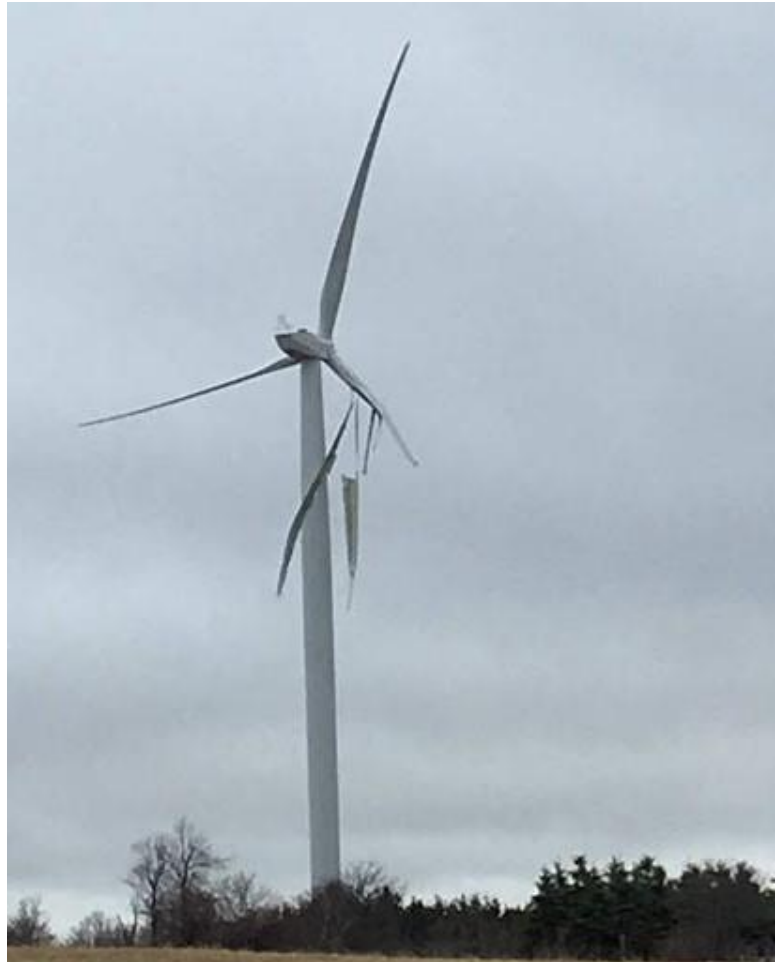
Attachment 4: Sumac Ridge, Kawartha Lakes

It was found that one of the blades of the turbine had shattered. Parts of the blade fell to the ground while other pieces were still dangling off of the remaining sections of the blade. The nearby road was closed to ensure public safety.

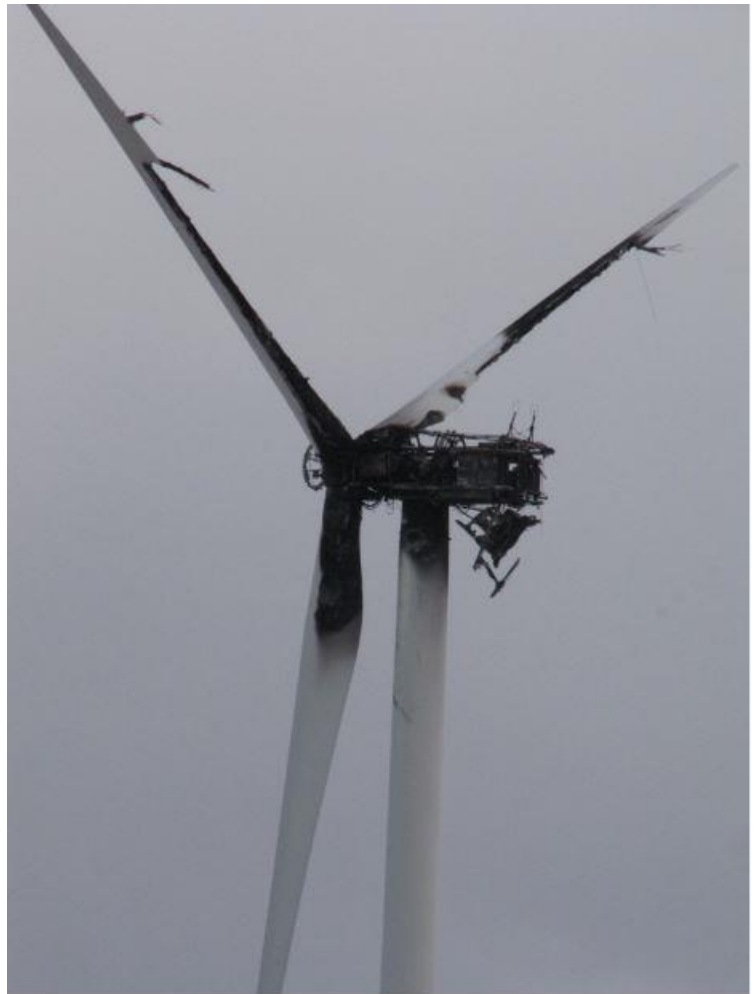
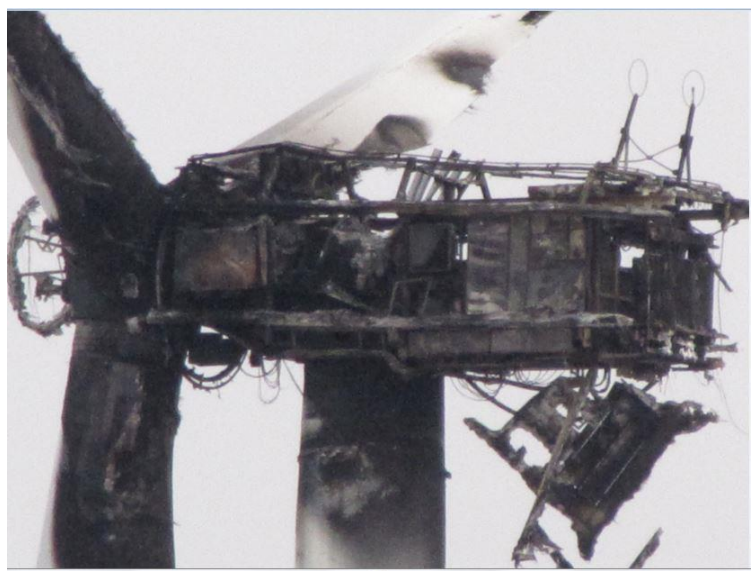
Attachment 5: Kingsbridge 1, Ashfield-Colborne-Wawanosh

The fire started at about 1 am and burned for about two hours. Most of the nacelle was completely destroyed. The intensity of the fire also ignited the blades.

Blades continued to rotate and could not be stopped due to the fire in control mechanisms.

This failure highlights the need for fire identification and suppression systems to be installed within the nacelles of all wind turbines.

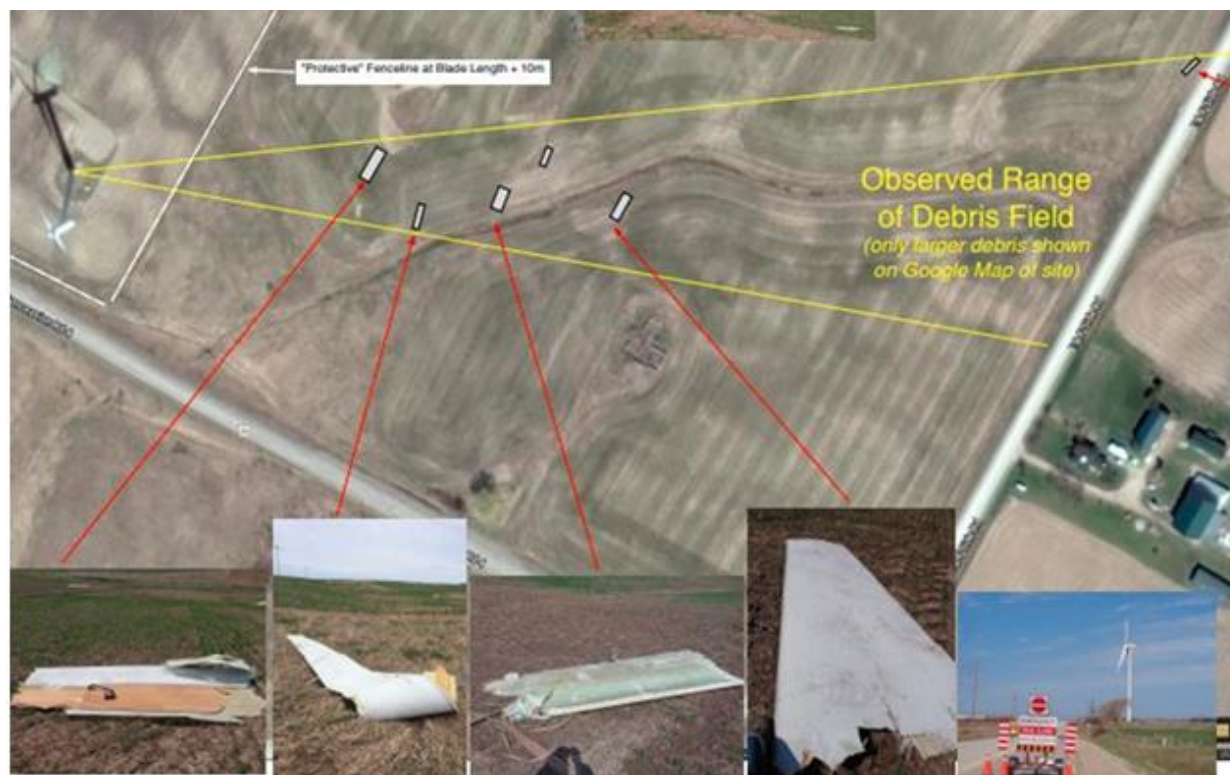
The map below compares the limit of the protected area of 50 m with the actual locations of debris from the blade failure. Large pieces of debris found 280 m from the tower.

Debris at 150m
from tower -
1.3m X 3.6m

Debris at
170m from
tower

Debris at 210 m
from tower
1.2m X 3.0m

Debris at
280m from
tower
1.2m X 3.0m

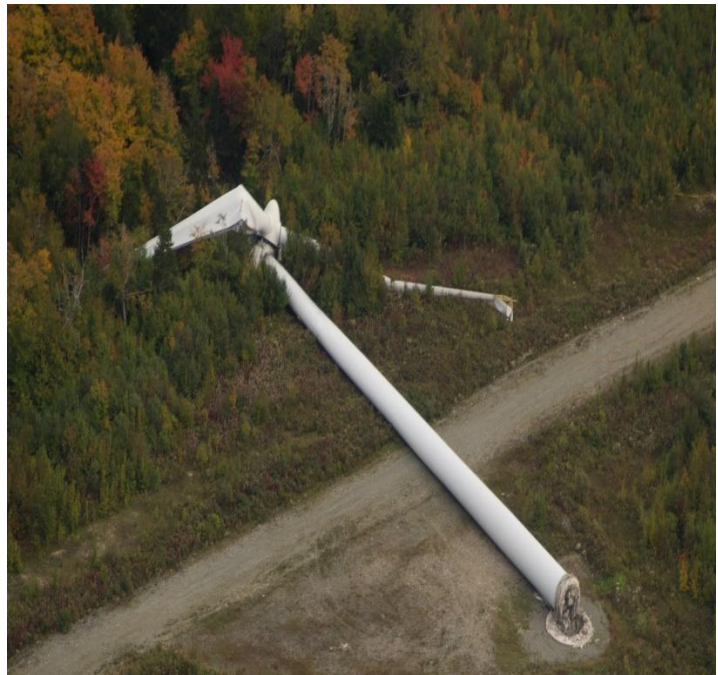
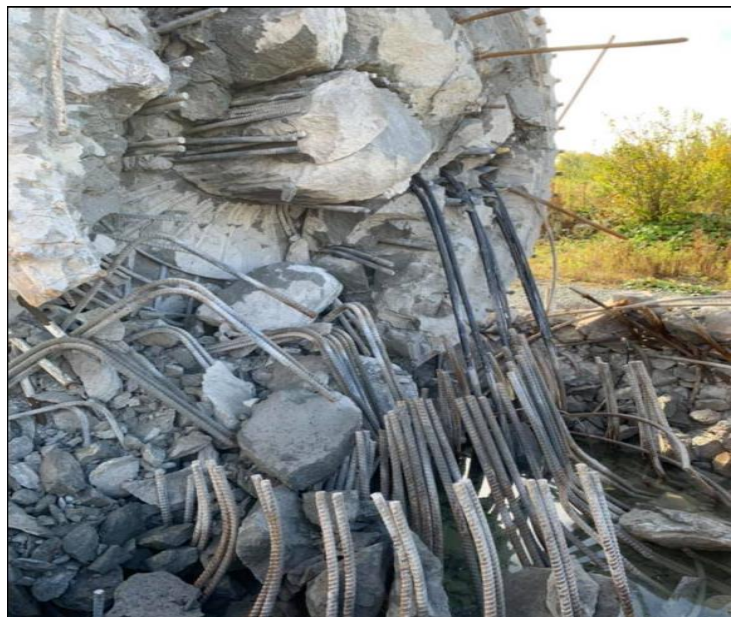
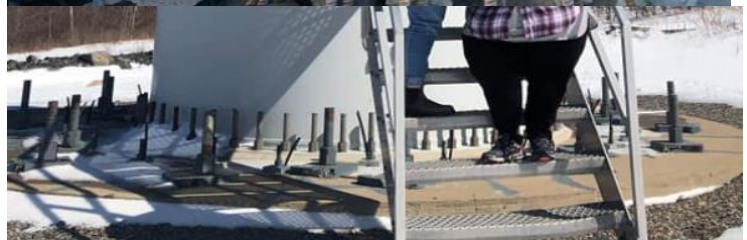
Attachment 7: Kent Hills, New Brunswick

As confirmed by the operator, this tower collapse was linked to a foundation failure (sub-surface crack propagation). The tower itself seems to have all the sections intact and bolted together. Basically, the pictures indicate that the top part of the foundation directly below the tower base was no longer adequately supporting the tower.

A close-up picture of the foundation shows the failed surfaces consists of concrete rubble and rebar. There does not seem to be evidence of the long primary anchor bolts that should fasten to the flange at the base of the tower and then be embedded deep into the concrete foundation.

Earlier pictures taken of wind turbines in this project indicate that numerous anchor bolts had been installed in the concrete bases. This is highly unusual and suggests that they were added when problems with the foundations became evident.
