B. M. ROSS AND ASSOCIATES LIMITED
Engineers and Planners
62 North Street, Goderich, ON N7A 2T4
p. (519) 524-2641 www.bmross.net

File No. 22234

November 17, 2022

TOWNSHIP OF SOUTHGATE HOLSTEIN DAM SAFETY REVIEW

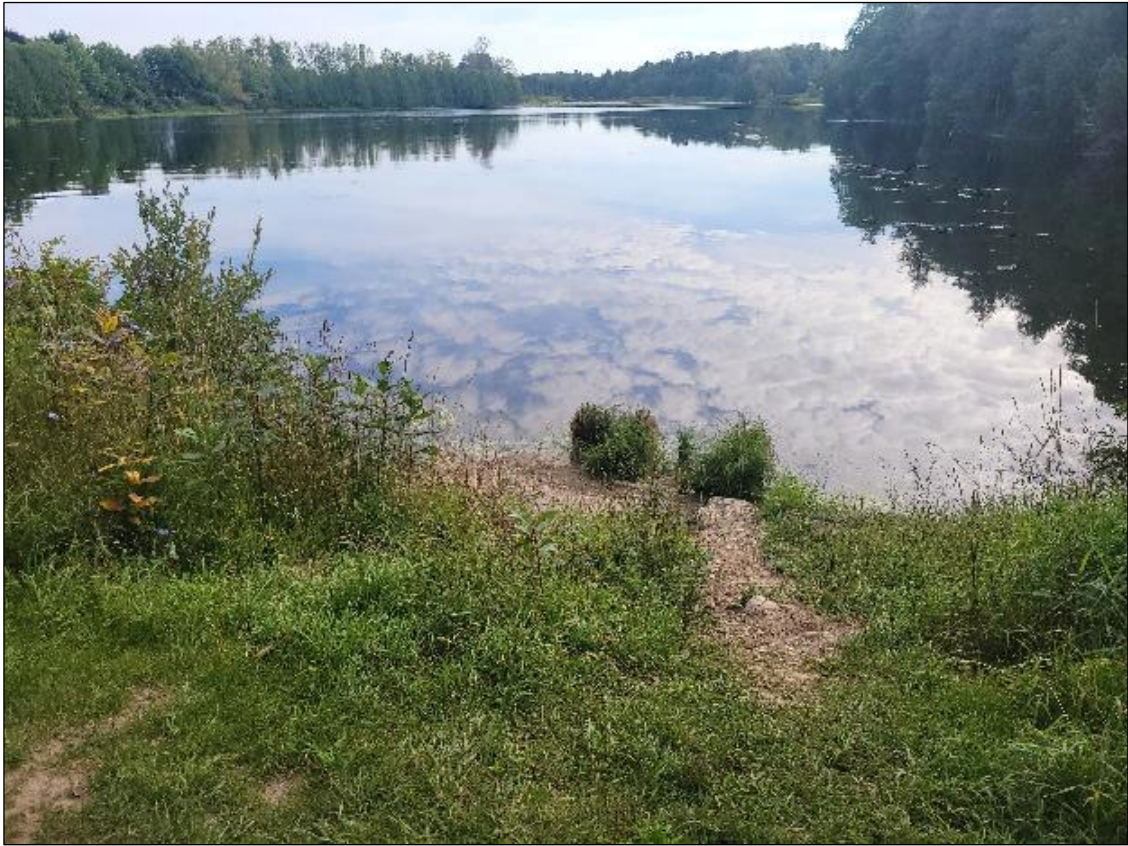
Head pond, looking east from dam

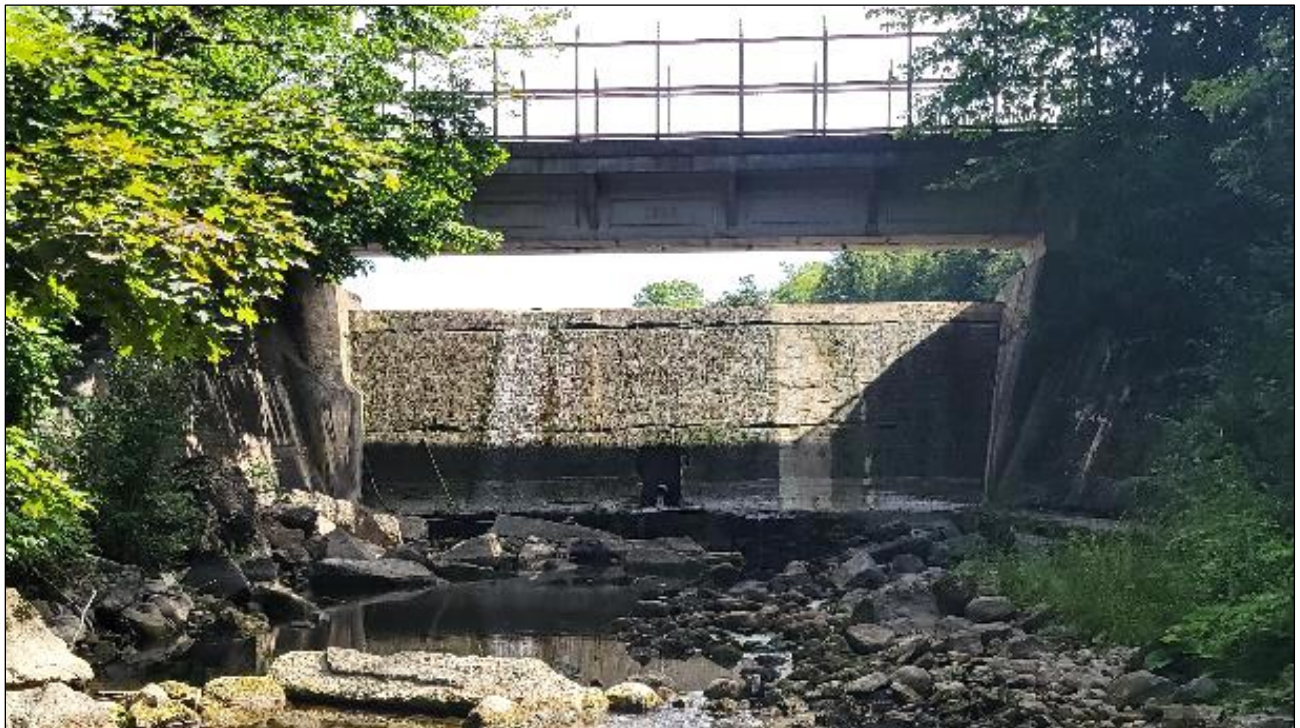
Looking upstream at spillway

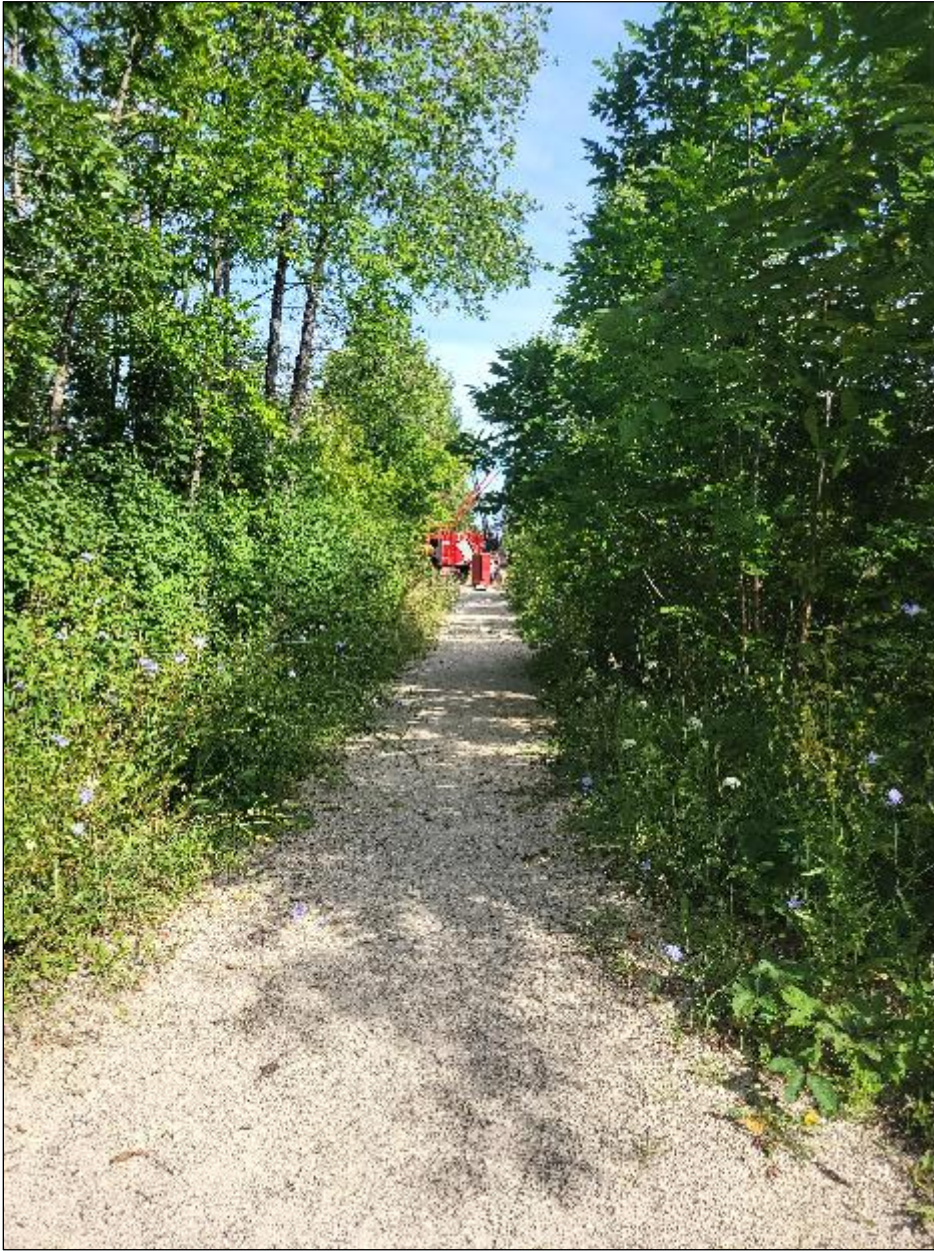
Crest, looking north. Vegetation on both upstream and downstream embankments.

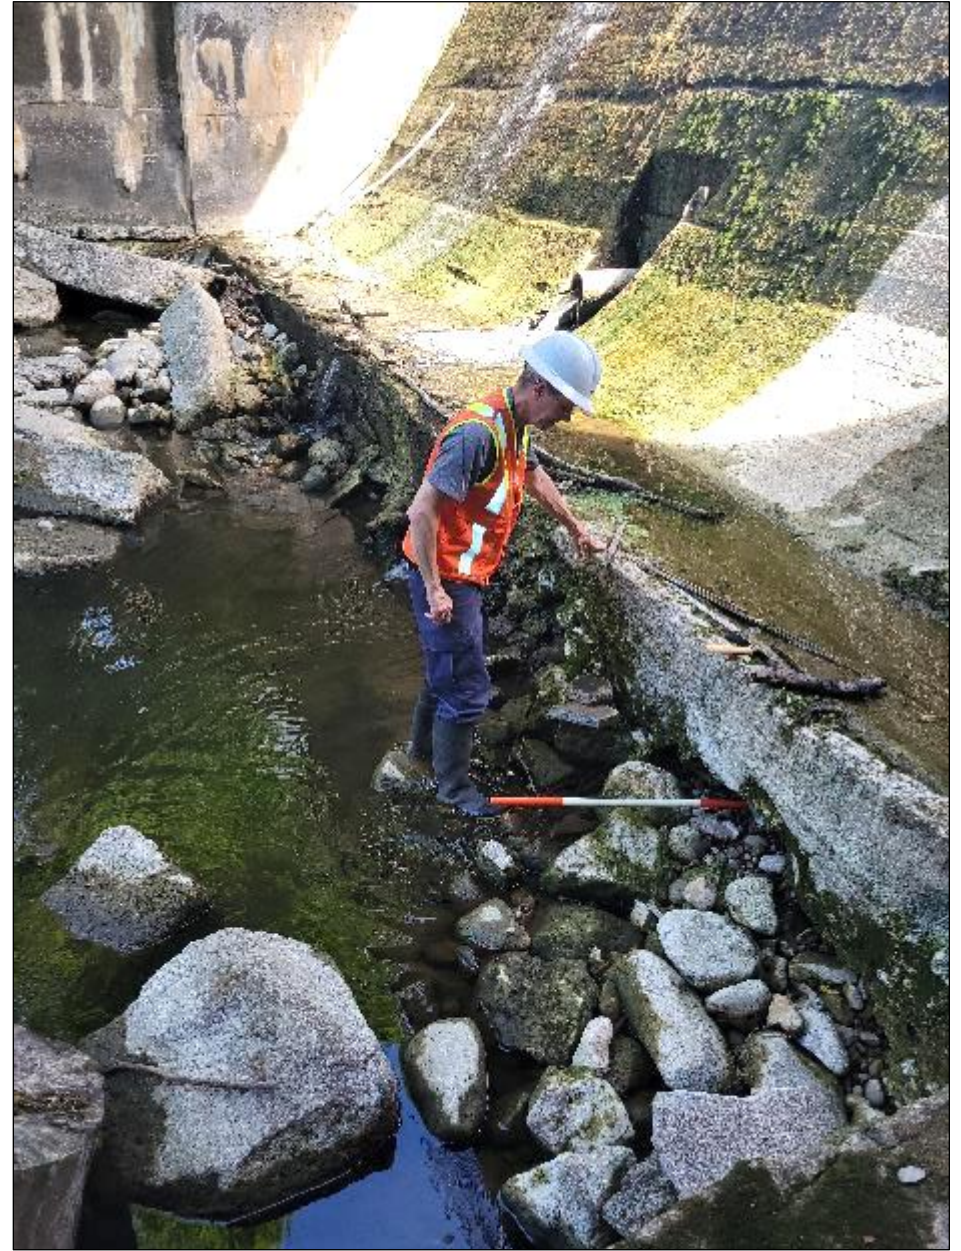
- The apron was undercut in one area (towards south) by 0.5 m.
- One decayed timber exposed, running E-W.

The footings of the two wingwalls and the spillway apron show signs of some scour and undermining. Although not severe at this time, the condition is likely to accelerate with each significant flow. It is recommended that a lean concrete grout be cast to fill the voids that exist under these foundations.

Undercut of spillway apron

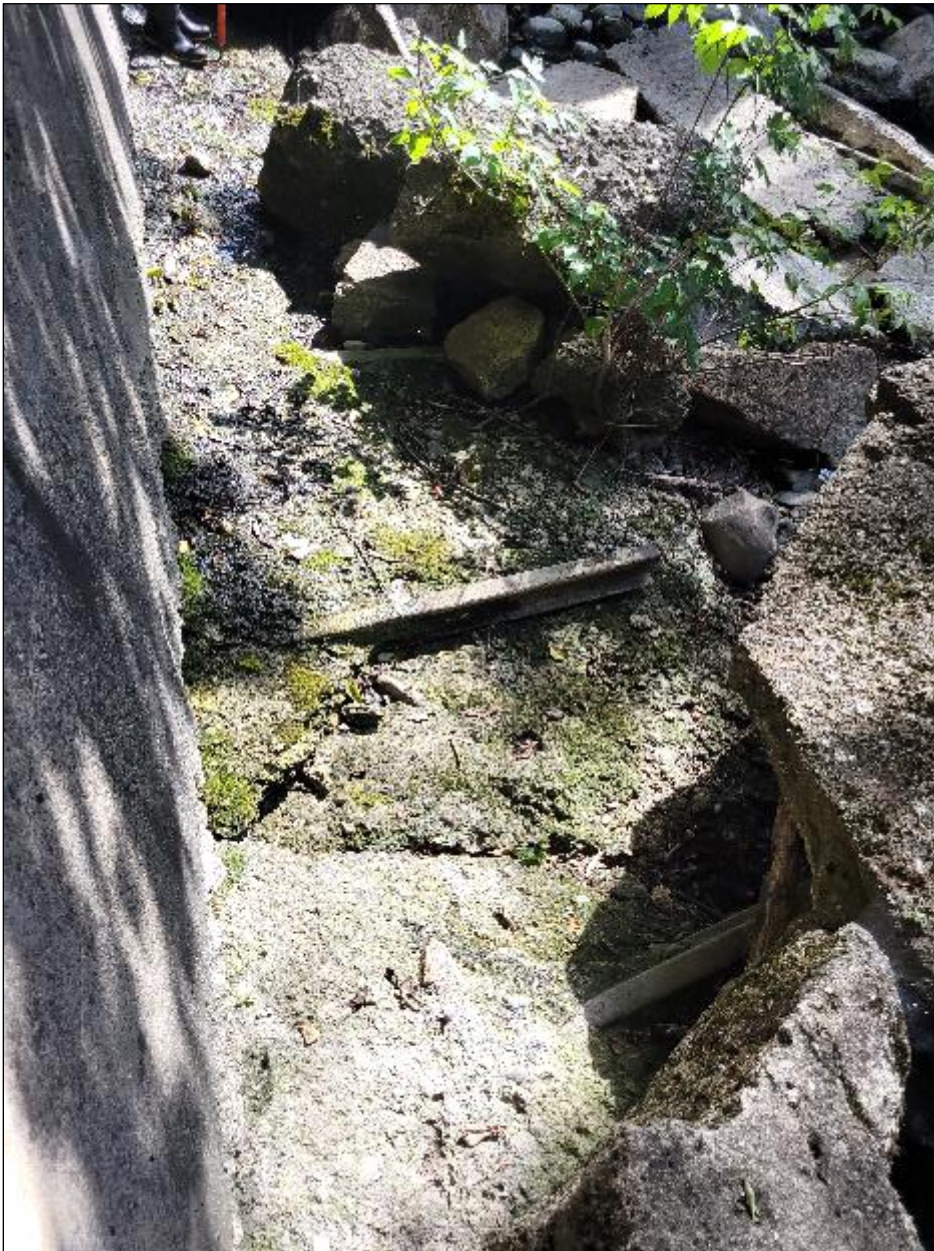
- Concrete about 90% fair and about 10% poor (delamination).
- Video taken during tap testing.
- The top of the apron/footing has been spalled or eroded and lateral lengths of steel rails are visible. Concrete missing from interface between wingwall bottom and top of apron.

North wingwall apron/footing with lateral lengths of steel rails visible
