PML Ref.: 19KF007 Report: 4

Excess Soil Management – Source Site Review White Rose Park Residential Subdivision, Phase 3 North of Bradley Street <u>Dundalk, Ontario</u>

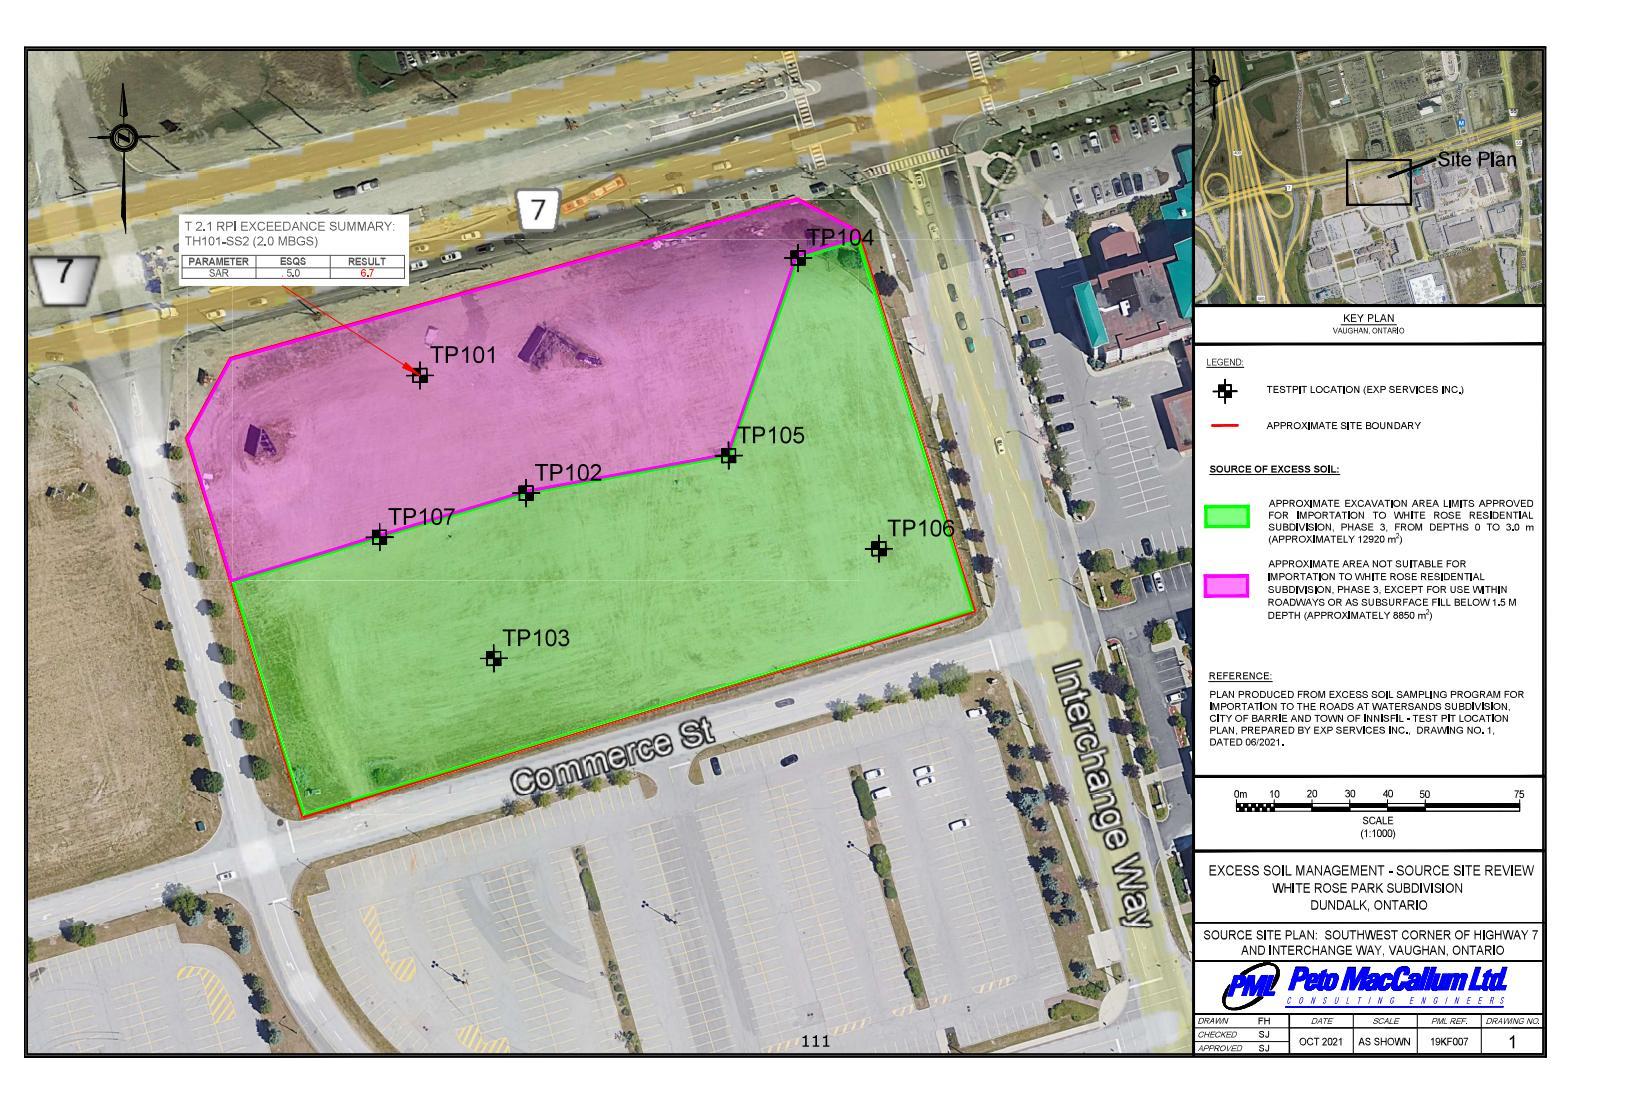
Based on the test results provided, an area of approximately 12,290 m² between 0.0 to 3.0 m depth in the south area of the site as shown on the attached Source Site Plan, Drawing 1, is suitable for importation to the White Rose Residential Subdivision, Phase 3 for use as general fill, subject to geotechnical suitability.

An approximate area of 8,850 m² in the north area of the site as shown on the attached source Site Plan, Drawing 1, is indicated to be impacted or potentially impacted with salt (EC and/or SAR) and is not suitable for importation to the White Rose Residential Subdivision, Phase 3, except where it can be placed in roadways and/or as subsurface fill, and subject to the placement restrictions outlined in O.Reg. 406/19 as previously discussed. Additional sampling and analytical testing at the Source Site can be undertaken by the Source Site QP to further delineate the extent of the SAR impacts and to refine the quantity estimates.

Enclosure(s): Drawing 1 – Source Site Plan Southwest Corner of Highway 7 and Interchange Way, Vaughan, Ontario Appendix A – Source Site Data Appendix B – Statement of Limitations
