## Ministry of Natural Resources & Forestry

### Delegation Brief:

1. Holstein Dam Sluice Failure and the concerns related to public safety, fish habitat and environmental concerns

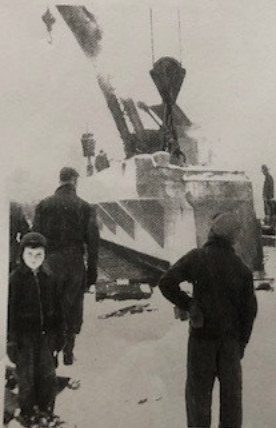
On top of the Grant Trunk Railroad bridge at the mill dam,  
early 1900's.  
(Photo courtesy Harry Mather)

In 1944 they rebuilt the railroad bridge over the dam. (see attached pictures on pages 52 & 53 from Holstein History book)

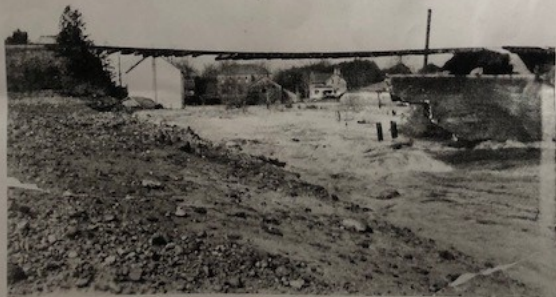
The Holstein Dam wash-out, 1929. Note the rail track suspended in mid air.  
(Photo courtesy Lloyd Seaman)

In 1929 the Holstein Dam wash out and was reconstructed at that time. (see attached pictures on pages 33 from Holstein History book)

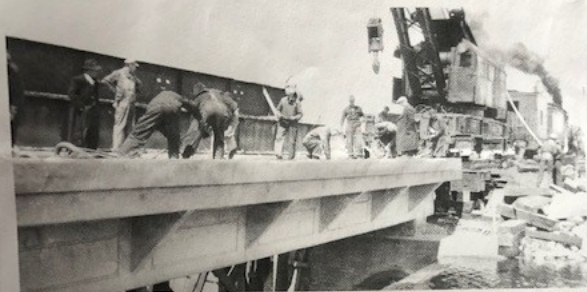
Rebuilding the railroad bridge over the dam, 1944.
